CorvetteRadios.Com

Refer to illustrations 15.11, 15.13, 15.17 and 15.19

Radio control

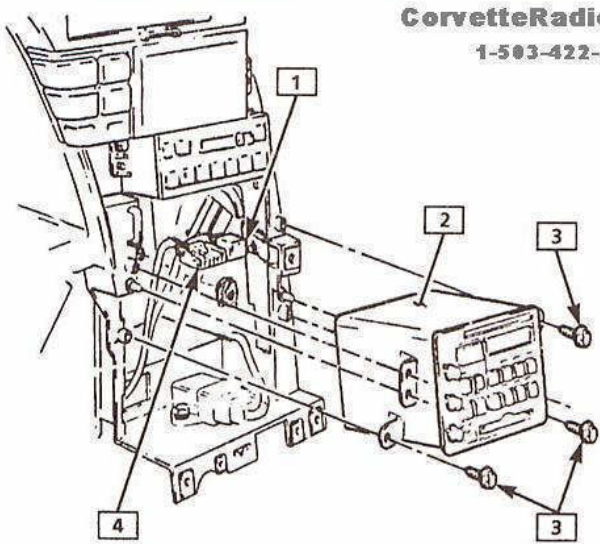
15.17 Radio control mounting details - 1990 and later models

| 1 Radio receiver harness connector | 3 Bolts |
| 2 Radio control | 4 Instrument panel harness connector |

- 15 Remove the screw on the right side of the driver information center to the upper trim panel.
- 16 Relocate the trim panel and pad to access the right hand radi control screw and remove the screw.
- 17 Remove the two screws holding the radio control to the instrument panel then slide the radio control out far enough to disconnect the electrical connector then remove the radio control (see illustration).
- 18 Installation is the reverse of removal.

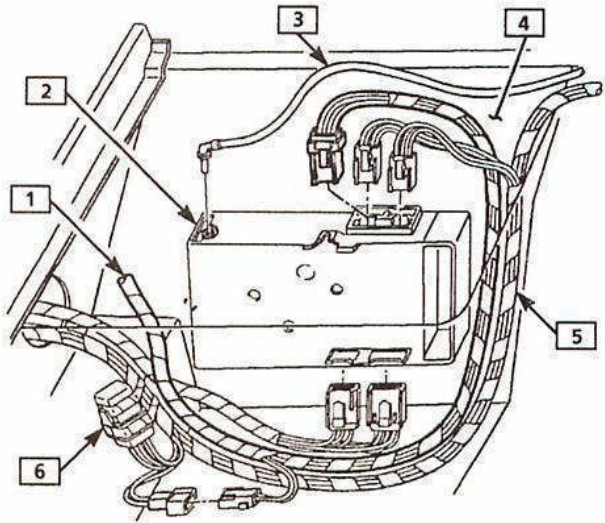
15.19 Radio receiver mounting details - 1990 and later models

| 1 Front body harness | 4 Right rear storage compartment |
| 2 Radio receiver | 5 Speaker harness |
| 3 Antenna extension cable | 6 Amplifier relay |

- 19 The radio receiver is located in the right rear cargo compartment and is held in place with Velcro fasteners (see illustration).
